Surface Tolerant Multipurpose Repair Material

1212

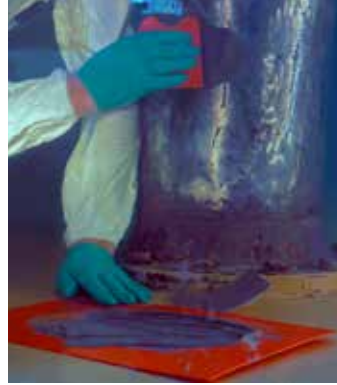
Underwater application

Belzona 1212 can be applied directly onto manually prepared, wet or oil-contaminated surfaces as well as underwater.

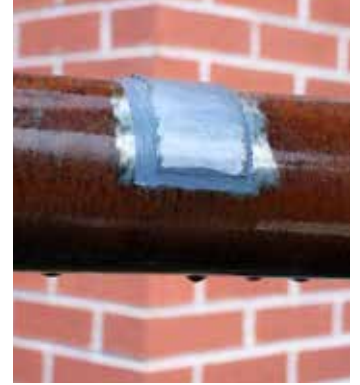
Application to wet, or oil contaminated surfaces
